C74-6502 PCB Patch Guide (v1.0 Boards)

The following patches were applied to the C74-6502 V1.0 prototype boards during debugging. Patches are divided into three categories:

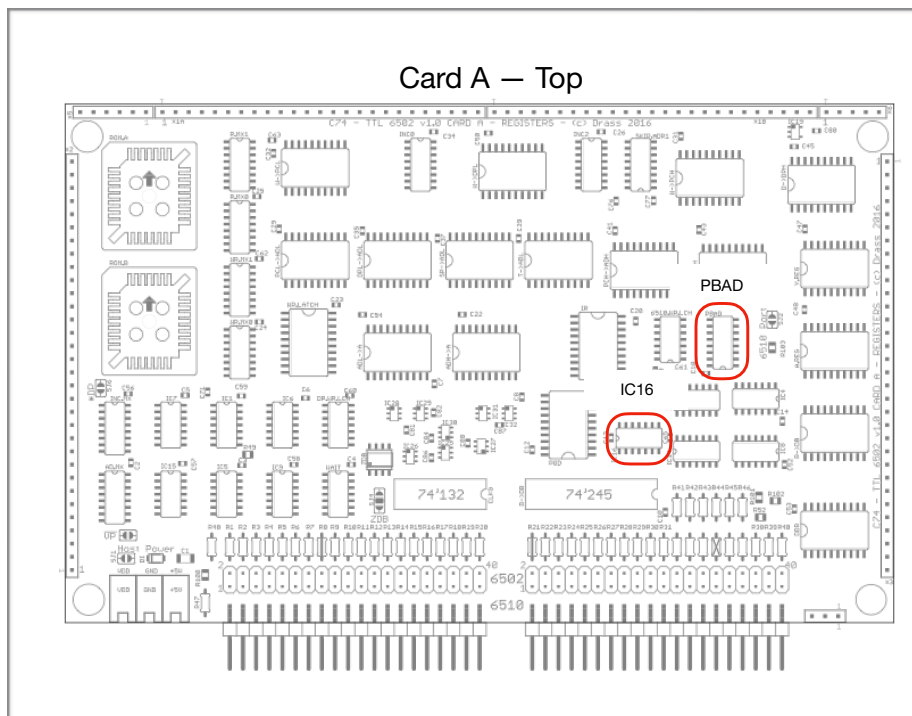
Patch 1:

1. 6510 PORT — REVERSED PINS ON PBAD, INVERTED POLARITY OF /BE

Description: The v1.0 boards had certain pins reversed on the PBAD IC (part of the 6510 port). This patch makes the correct connections on PBAD, and skips the inverter on PBAD.5 to have the right polarity.

- Card A: PBAD.11 (LIFT) —> PBAD.10 (PAD)
- Card A: PBAD.10 (LIFT) —> PBAD.11 (PAD)
- Card A: PBAD.7 (LIFT) —> PBAD.9 (PAD)
- Card A: PBAD.9 (LIFT) —> PBAD.7 (PAD)
- Card A: IC16.3 (LIFT)
- Card A: IC16.3 (PAD) —> PBAD.5 (LIFT)

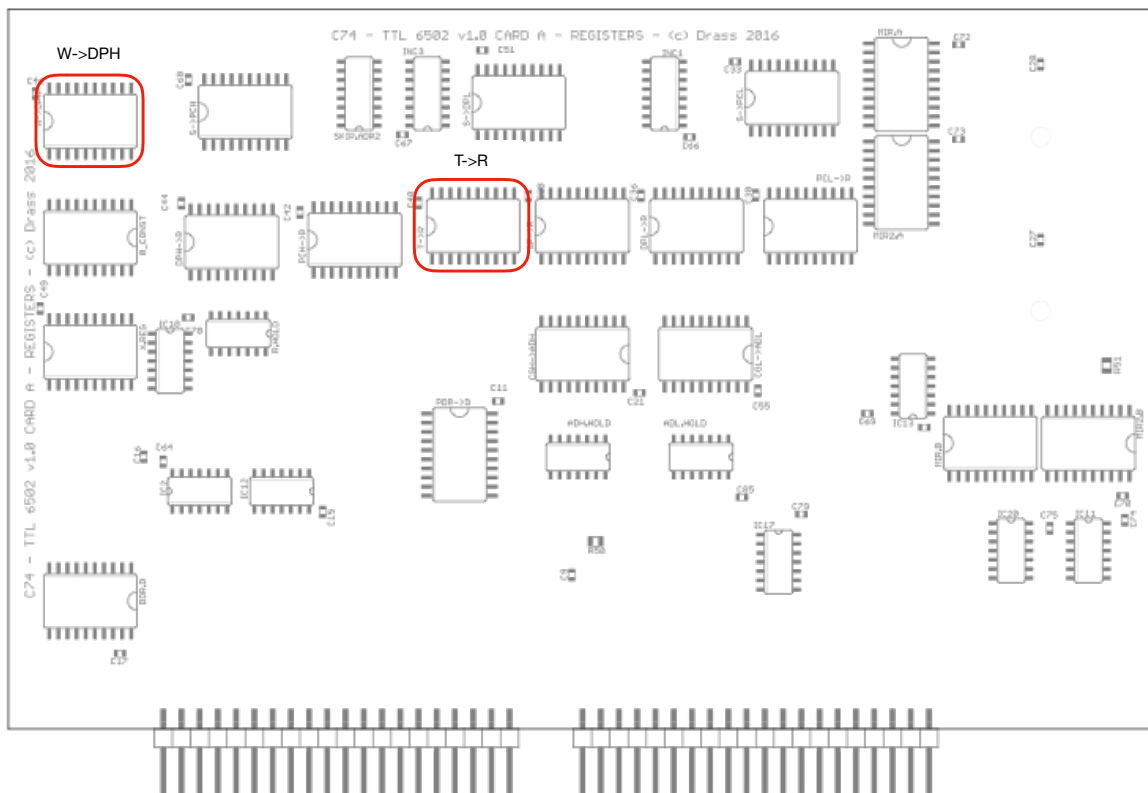
Card A — Bottom

2. T->R INPUTS PINS REVERSED

Description: The v1.0 boards had pins on the T->R buffer reversed. This patch corrects these connections.

- Card A: T->R.7 (PAD) → T->R.6 (LIFT)
- Card A: T->R.8 (PAD) → T->R.7 (LIFT)
- Card A: T->R.9 (PAD) → T->R.8 (LIFT)
- Card A: W->DPH.9 → T->R.9 (LIFT)

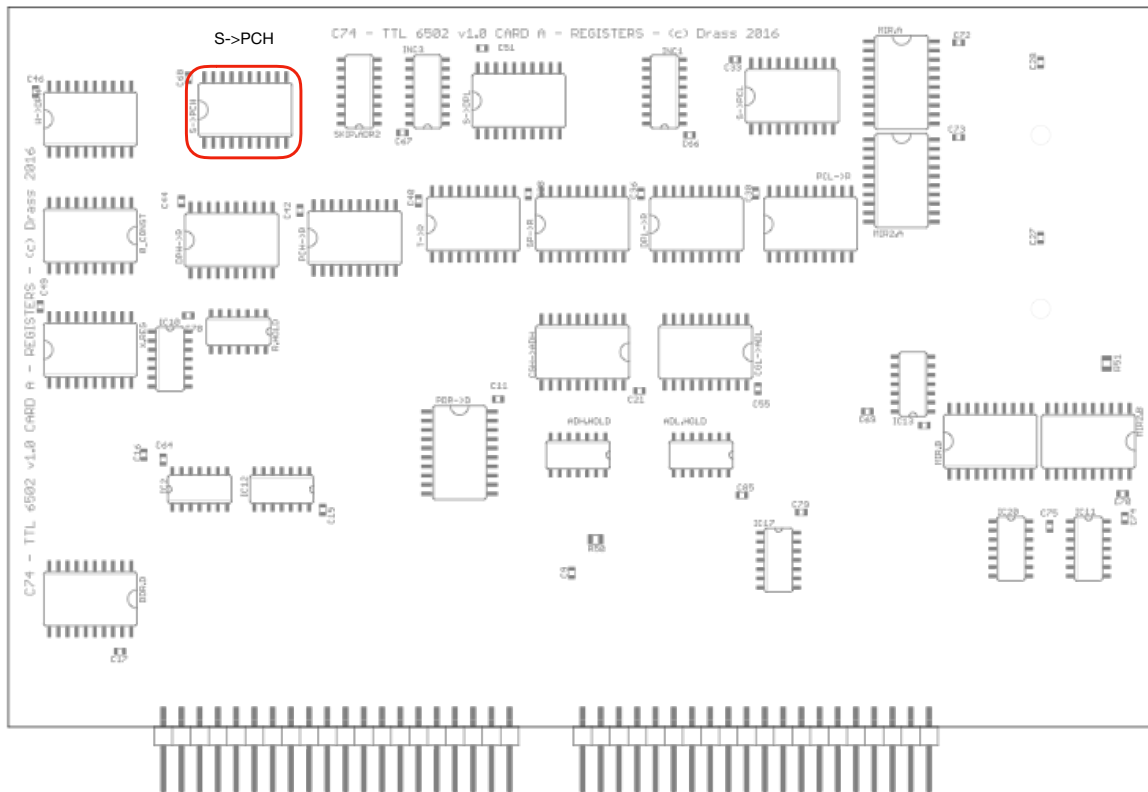
Card A — Bottom

2A. S->PCH OUTPUT PINS REVERSED

Description: The original schematics had pins on the S->PCH buffer reversed. This patch corrects there connections.

- Card A: S->PCH.11 (LIFT) -> S->PCH.18 (PAD)
- Card A: S->PCH.12 (LIFT) -> S->PCH.17 (PAD)
- Card A: S->PCH.13 (LIFT) -> S->PCH.16 (PAD)
- Card A: S->PCH.14 (LIFT) -> S->PCH.15 (PAD)
- Card A: S->PCH.15 (LIFT) -> S->PCH.14 (PAD)
- Card A: S->PCH.16 (LIFT) -> S->PCH.13 (PAD)
- Card A: S->PCH.17 (LIFT) -> S->PCH.12 (PAD)
- Card A: S->PCH.18 (LIFT) -> S->PCH.11 (PAD)

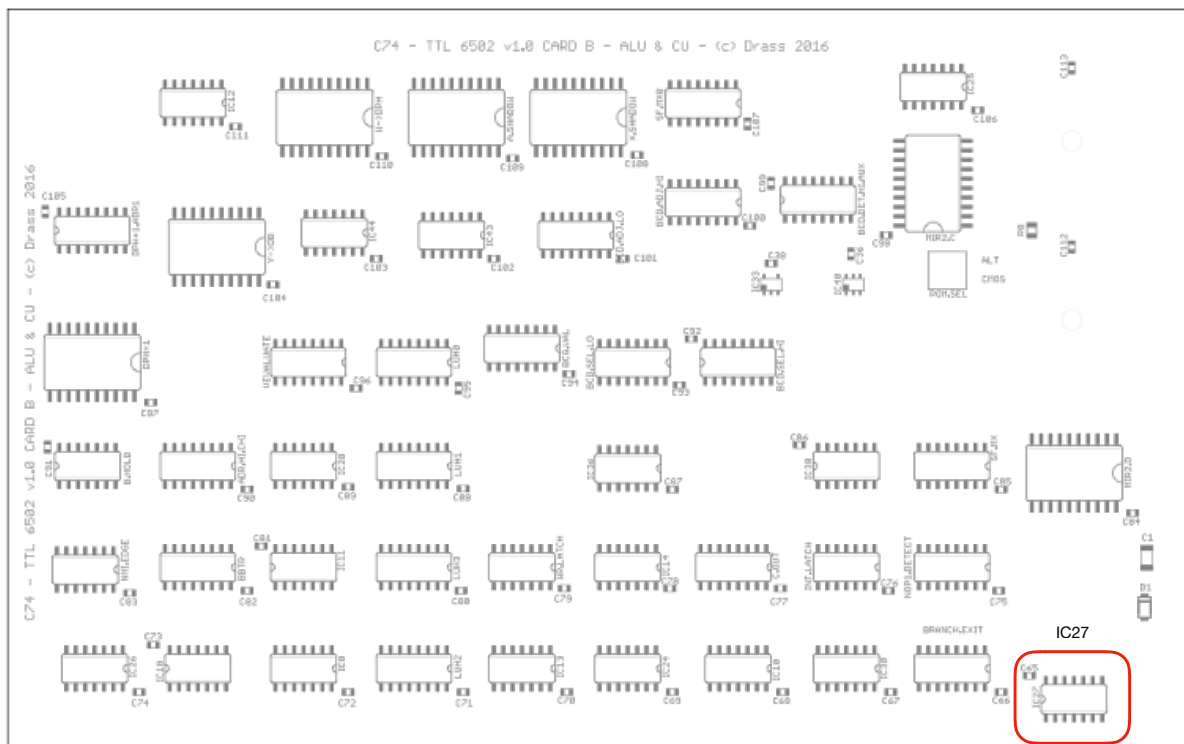
Card B — Bottom

3. 65C02 NOP1 OPCODES

Description: NOP1 opcodes are single cycle NOPs present in the 65C02 instruction set. A bug in the sequencer logic prevented these from being executed properly. Fixing this bug also simplified the sequencer logic and microcode. For that reason, this patch is required for all instruction sets, and must be made for the CPU to work properly. The patch involves jumpers on both the top and bottom of Card B.

- Card B: IC27.14 → IC27.1 (LIFT) [IC27 = silkscreen IC50]

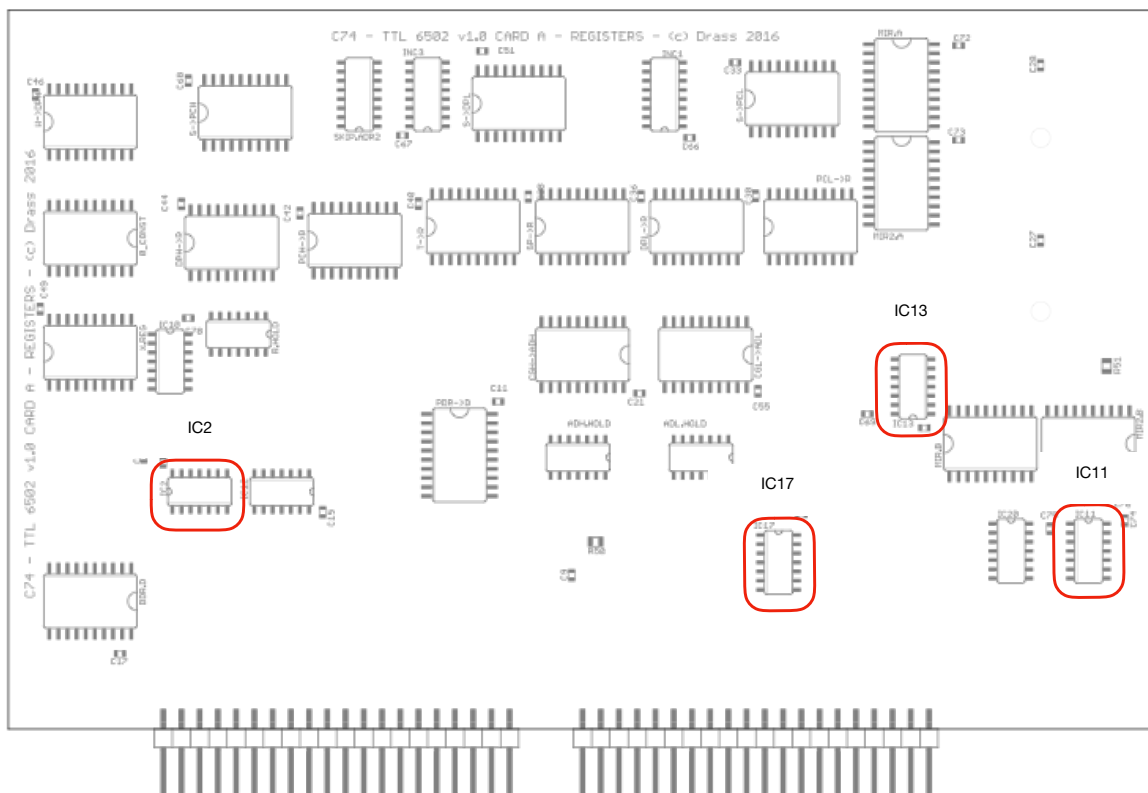
Card A — Bottom

4. R/W TAKES TOO LONG BEYOND 16MHZ

Description: Speed tests revealed that the CPU takes too long to generate R/W when operating above 16MHz. This patch reduces the propagation delay for the R/W signal by taking one gate out of the path.

- Card A: IC11.10 → IC17.9 (LIFT)
- Card A: IC13.3 → IC17.10 (LIFT)
- Card A: IC17.8 → IC2.12
- Card A: IC5.10 (LIFT)

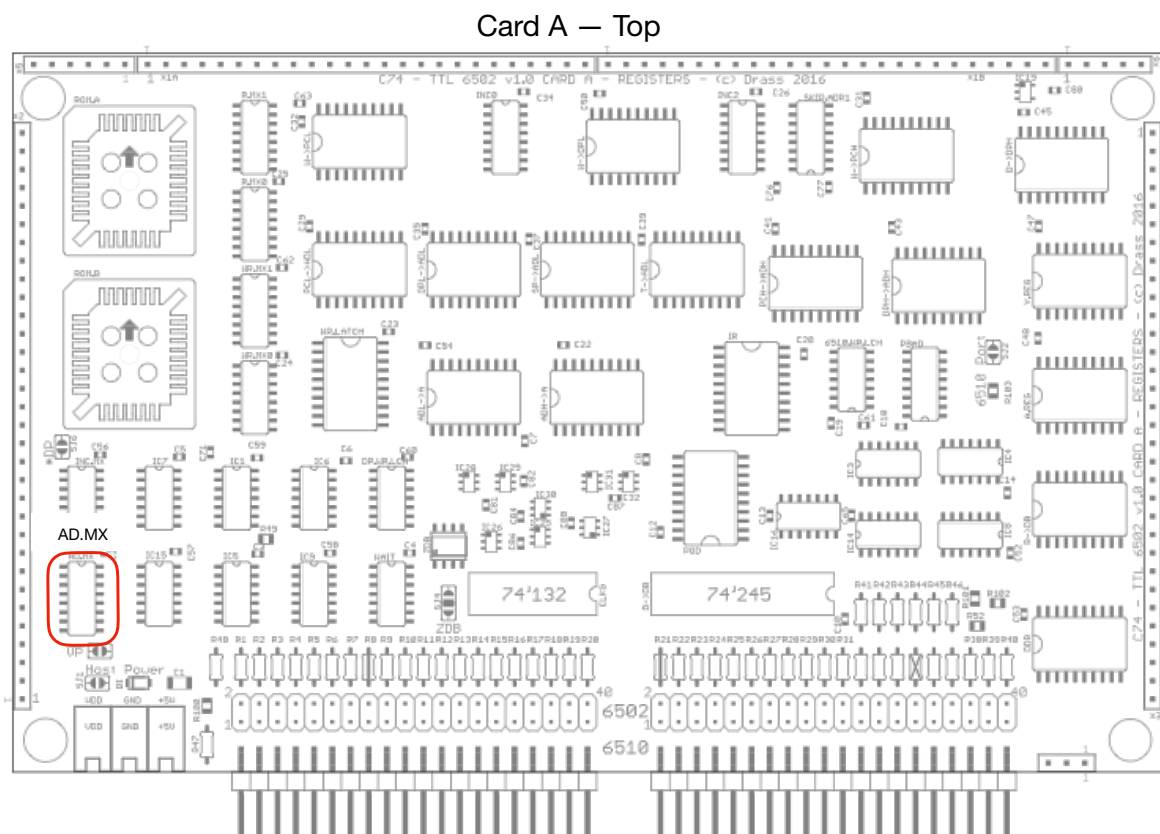
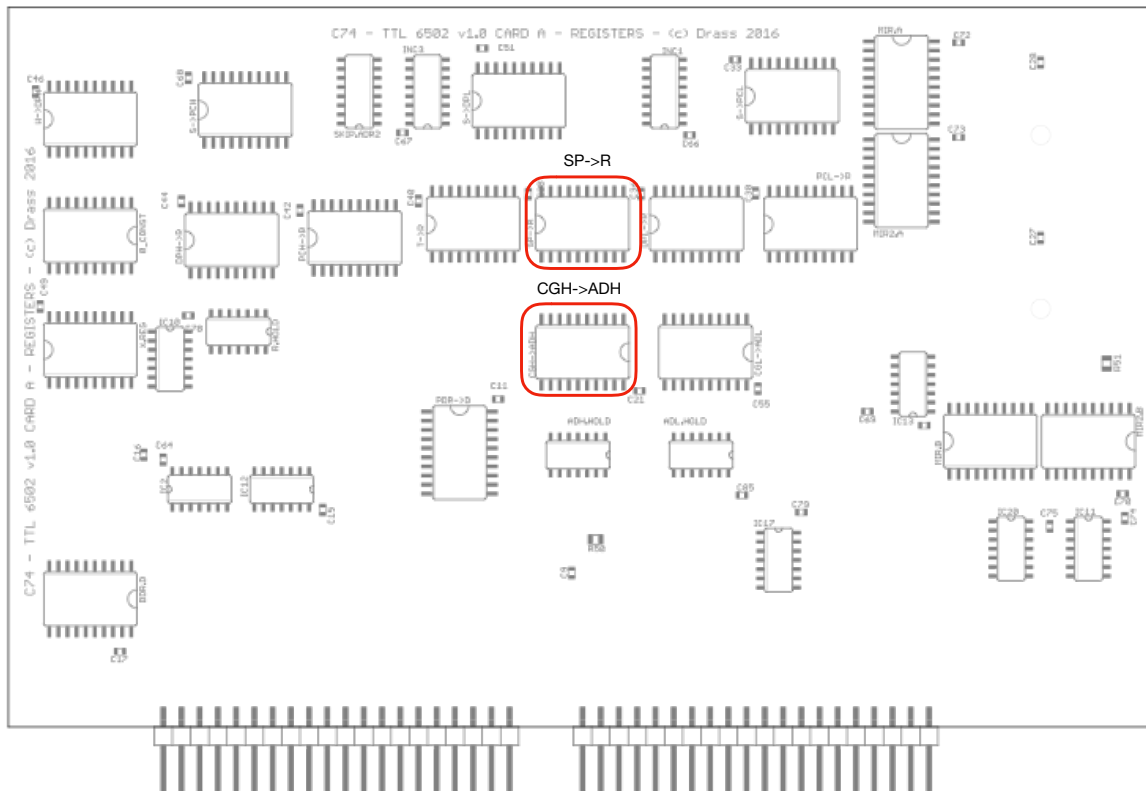
Patch 5:

5. COMPATIBILITY WITH BUS SHARING SCHEMES

Description: The C74-6502 was designed to drive the bus during Phase 1 only. This is in order to avoid transient bus collisions at high speeds. Unfortunately, this bus scheme is not compatible with systems where the CPU shares control of the bus with other peripherals (such as on the Commodore 64 and others). This patch will cause the CPU to drive the bus during Phase 2 as well as Phase 1. This will lead to short transient collisions on the bus during state transitions, but these are benign and can be safely ignored.

- Card A: AD.MX.5 → AD.MX.4 (LIFT)
- Card A: SP→R.10 → CGH→ADH.1 (LIFT)

Note: Need to test whether applying this patch inhibits operation at the highest clock-rates. If so, consider replacing ADL.A and ADH.A 74CBT3245s with 74AC541s.

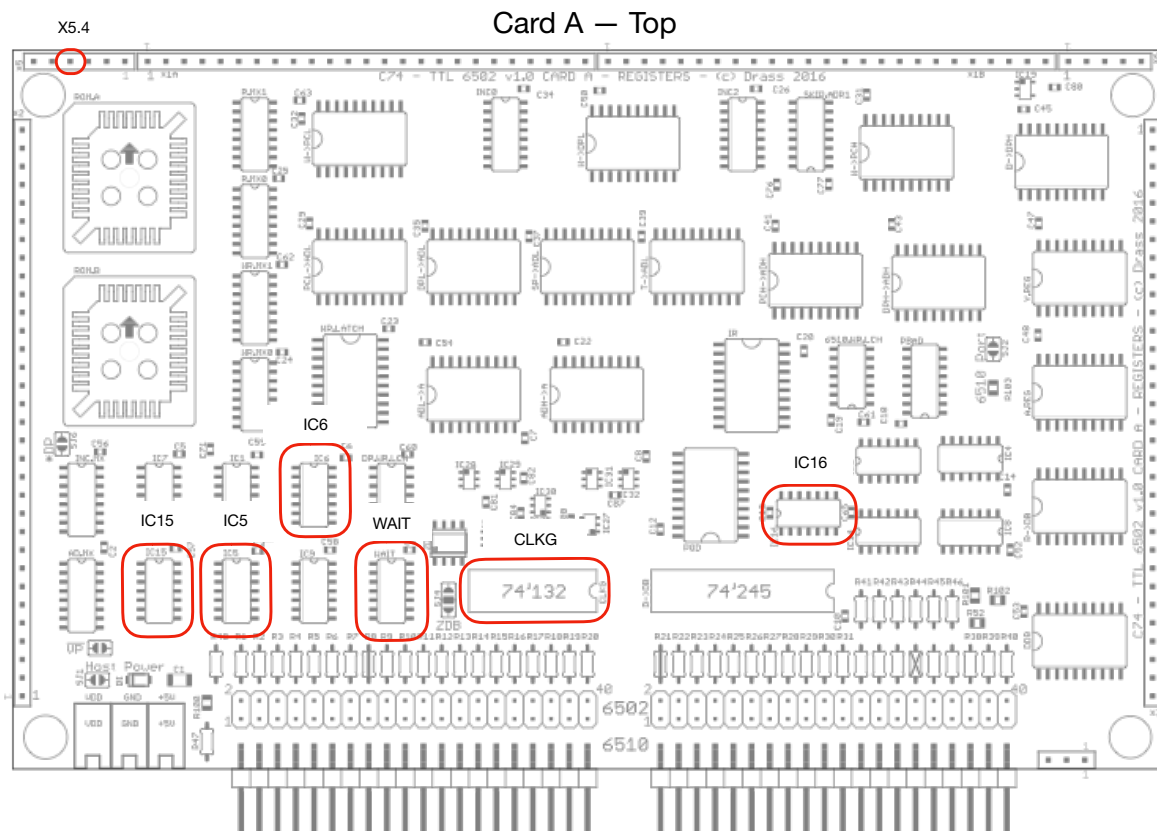
Patch 6:

6. RDY TAKES EFFECT ONE CYCLE TOO LATE AND RDY NMOS 6502 COMPATIBILITY

Description: The RDY signal is meant to pause the CPU during Phase 2 of the cycle in which it is detected. Instead, the TTL CPU was pausing during Phase 1 of the following cycle. In addition, RDY should not pause the CPU on reads when emulating the NMOS 6502 but should do so for the 65C02. This patch will cause the RDY to correctly pause the CPU during Phase 1, and its behaviour will adjust automatically based on the active instruction-set.

- Card A: CLKG.4 → CLKG.5 (LIFT)
- Card A: CLKG.5 (SOCKET) → WAIT.2 (LIFT)
- Card A: CLKG.6 → IC6.9 (LIFT)
- Card A: IC6.11 → IC6.10 (LIFT)
- Card A: X5.4 → IC16.3 (LIFT)
- Card A: IC16.4 → IC6.12 (LIFT)
- Card A: IC15.12 → IC6.13 (LIFT)
- Card A: IC6.8 → WAIT.10 (LIFT)
- Card A: WAIT.4 → WAIT.1 (LIFT)
- Card A: WAIT.6 (LIFT)
- Card A: WAIT.5 → WAIT.6 (PAD)
-

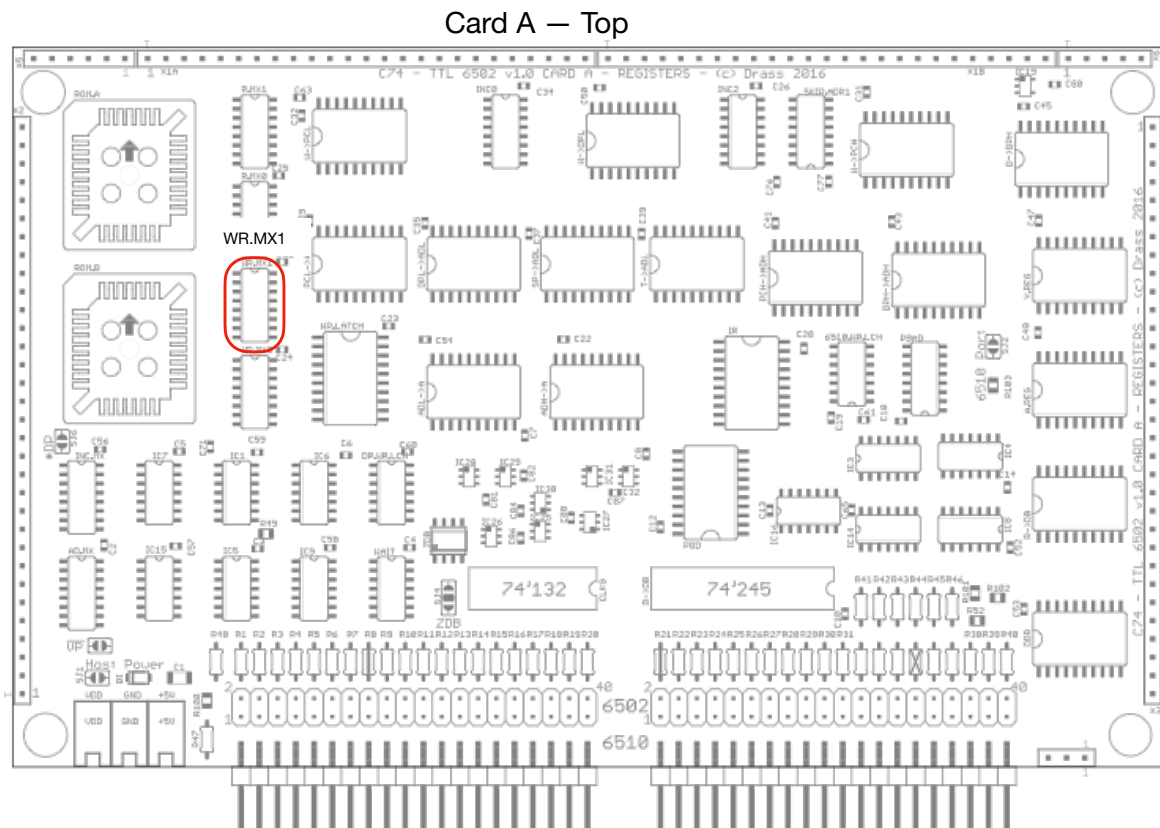
Patch 7: Part 1

7. NMOS 6502 MODIFY CYCLE WRITE

Description: The NMOS 6502 performs a Read-Write-Write sequence for RMW instructions (INC, DEC, ASL, etc.). The C74-6502 was designed to duplicate the 65C02 behaviour, which is Read-Read-Write. This patch will cause a Write to be performed during the Modify (middle) cycle when the NMOS 6502 instruction-set is selected.

- Card A: WR.MX1.9 (LIFT)

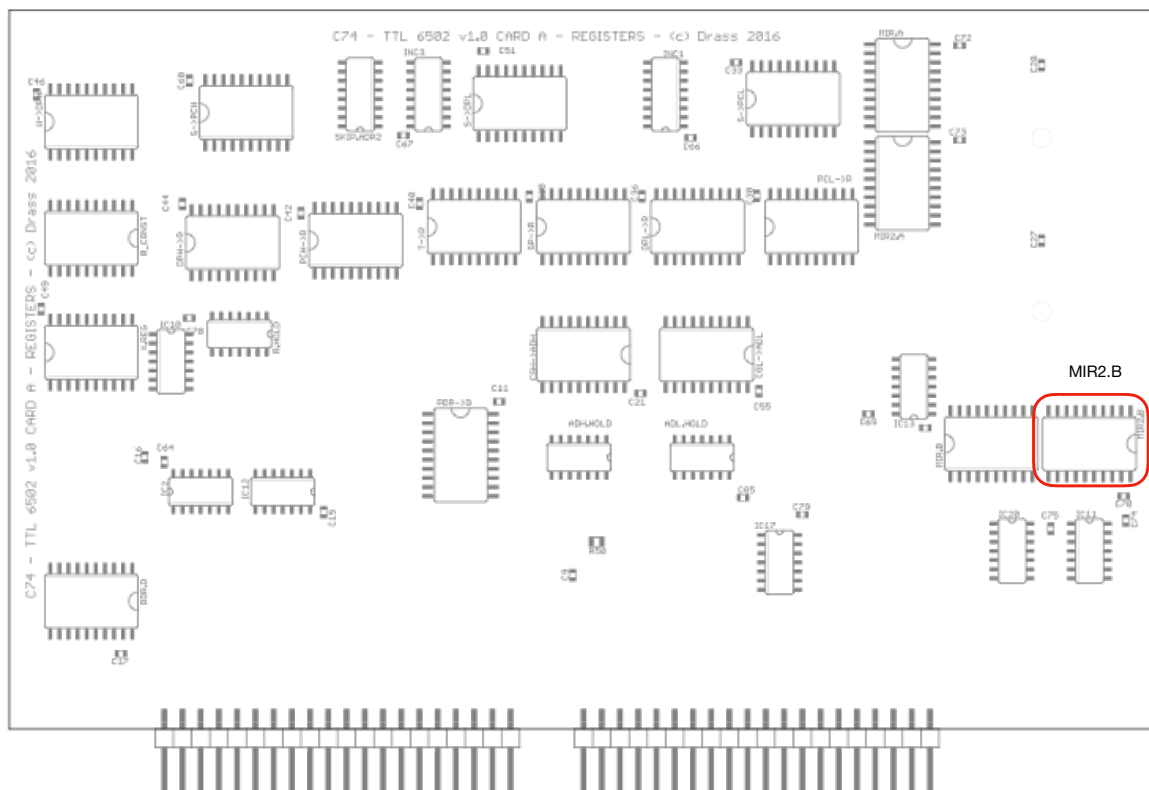
Card A — Bottom

8. DEAD-CYCLE — NMOS VS. CMOS COMPATIBLE BEHAVIOUR

Description: The NMOS 6502 produces partial addresses on the bus during address calculation. This was changed on the 65C02, which leaves in place the Previous Bus Address in those situations. This patch enables the “*DP” jumper to select between these two behaviours, leaving the jumper open for NMOS compatible operation, and closing it for CMOS operation.

- Card A: MIR2.B.3 —> MIR2.B.6 (LIFT)
- Card A: MIR2.B.6 (PAD) —> MIR2.B.7 (LIFT)

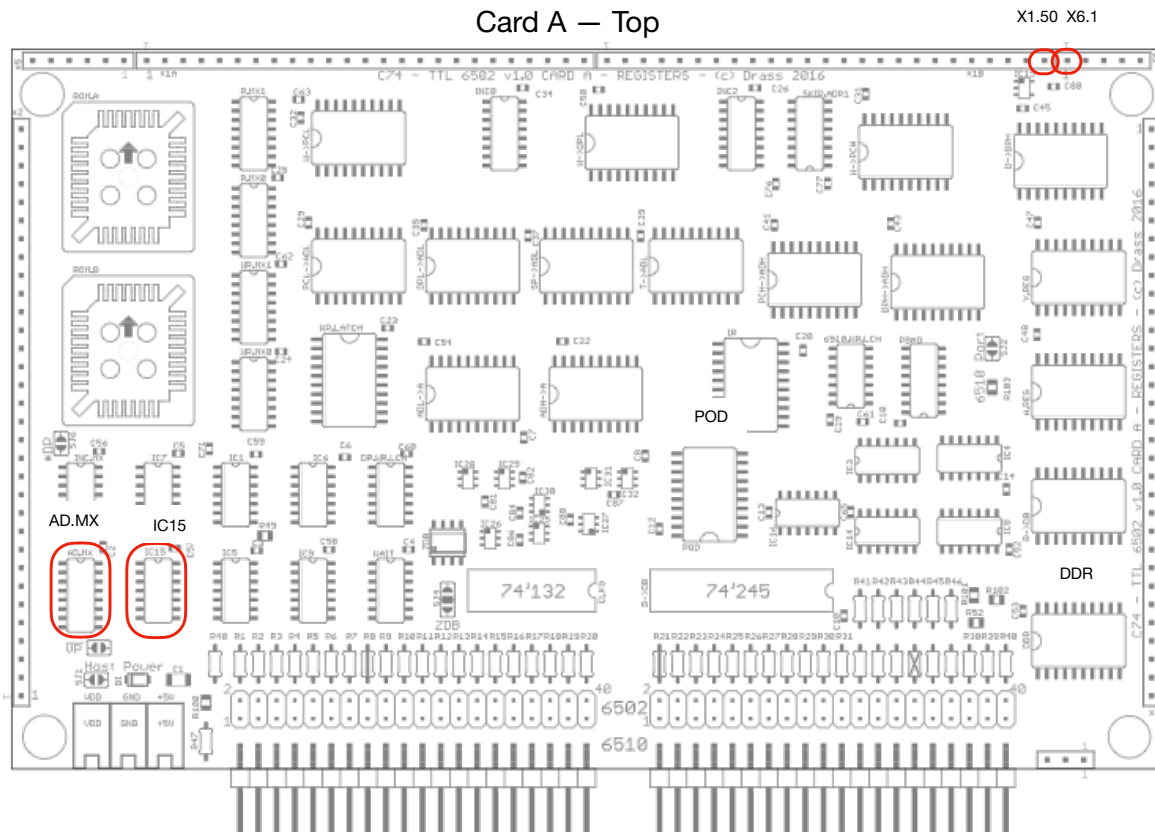
Patch 9: Part 1

9. NMI INCORRECTLY INTERRUPTS IRQ

Description: This patch fixes a bug where the CPU will loose an IRQ if an NMI happens to arrive just as the IRQ vector is being fetched by the CPU.

- Card A: AD.MX.7 → X1.50
- Card A: IC15.1 → IC15.13 (LIFT)
- Card A: X6.1 → POD.1 (LIFT) → DDR.1
